Manhole Inspection Summary

Manhole # S25EE2007MH

Location Address: **816 DROHOMER PL**

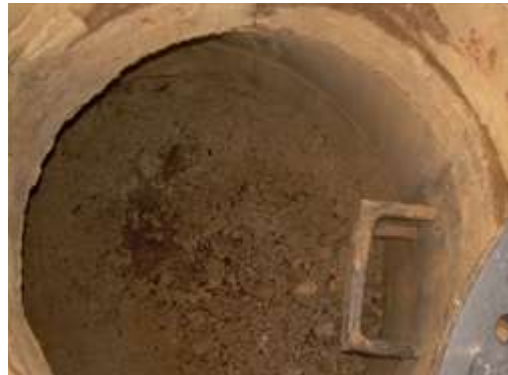
Top View

Channel debris.

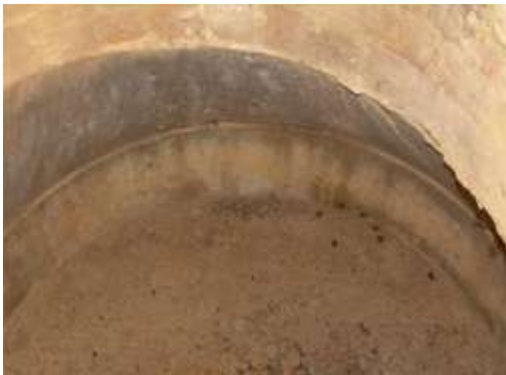
Defect

Barrel infiltration. Channel debris.

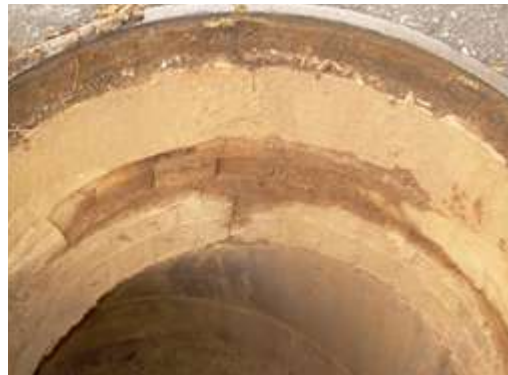
Defect

☒ **Leaks**

Condition: ☐ Sound ☐ Cracked ☐ Root Intrusion ☒ **Loose Brick** ☒ **Deteriorated**

Infiltration: ☐ None ☒ **Joint** ☐ Cracks ☒ **Mortar** ☐ Roots ☐ Wall

Infiltration: ☐ None ☒ **Joint** ☐ Cracks ☐ Mortar ☐ Roots ☐ Wall

Frame leaks. Adjustment deterioration, loose brick and infiltration. Corbel infiltration.

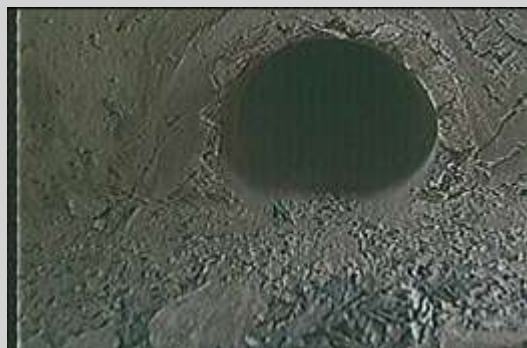
Pipe Out @ 12 O'Clock

8 in. Circular Gravity Sewer

Deposits: ☐ None ☒ **Mud** ☐ Sludge ☒ **Debris** ☐ Grease

Deposits Extent: **Light**
